REDEVELOPMENT INCENTIVE GRANT PROJECT APPLICATION

Project Name: **Roers – Town Center 1 Redevelopment**

Report of Inspection Procedures and Results for
Determining Qualifications of a
Tax Increment Financing District as a Redevelopment District

**West Saint Paul Town Center 1
Redevelopment TIF District
West Saint Paul, Minnesota**

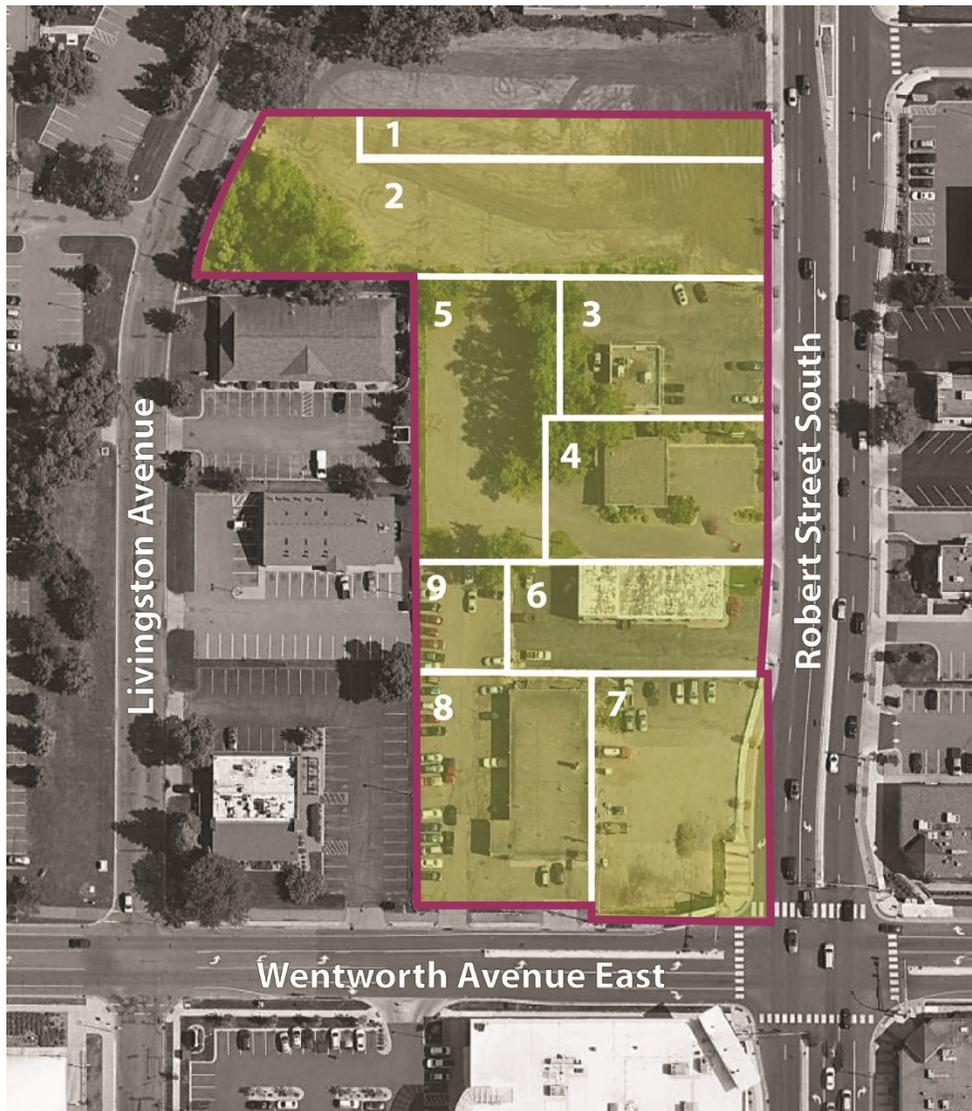
Diagram 1 – Proposed TIF District

LHB was hired by the City of West Saint Paul to inspect and evaluate the properties within a Tax Increment Financing Redevelopment District (“TIF District”) proposed to be established by the City. The proposed TIF District is located near the northwest corner of Wentworth Avenue East and Robert Street South (Diagram 1). The purpose of LHB’s work is to determine whether the proposed TIF District meets the statutory requirements for coverage, and whether four (4) buildings on nine (9) parcels, located within the proposed TIF District, meet the qualifications required for a Redevelopment District.

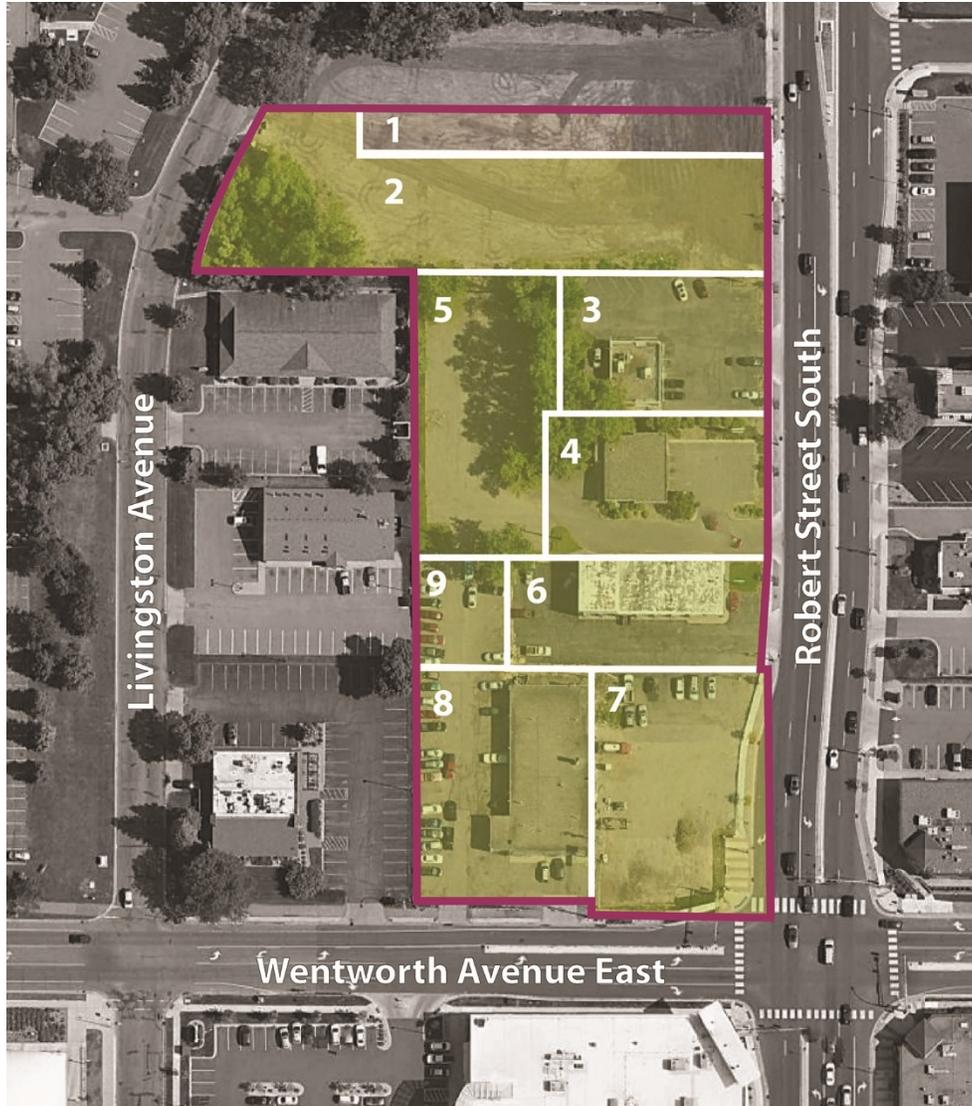
Diagram 2 – Coverage Diagram

The proposed TIF District met the coverage test under *Minnesota Statutes, Section 469.174, Subdivision 10(e)*, which resulted in parcels consisting of 94.5 percent of the area of the proposed TIF District being occupied by buildings, streets, utilities, paved or gravel parking lots, or other similar structures (Diagram 2). This exceeds the 70 percent area coverage requirement for the proposed TIF District under *Minnesota Statutes, Section 469.174, Subdivision (a) (1)*.

Shaded area depicts a parcel more than 15 percent occupied by buildings, streets, utilities, paved or gravel parking lots or other similar structures

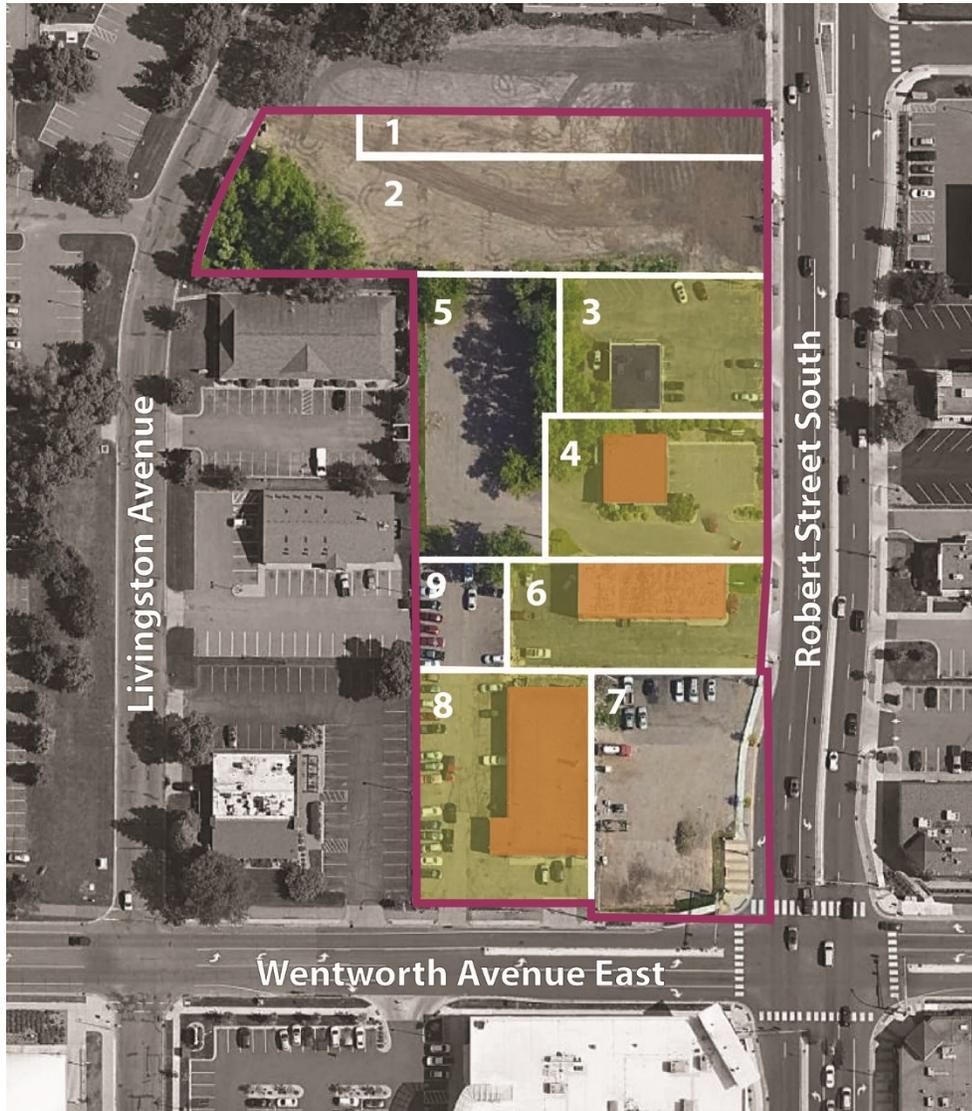
Diagram 3 – Substandard Buildings

The parcels with substandard buildings are reasonably distributed compared to all parcels that contain buildings.

Shaded green area depicts parcels with buildings.
Shaded orange area depicts substandard buildings.

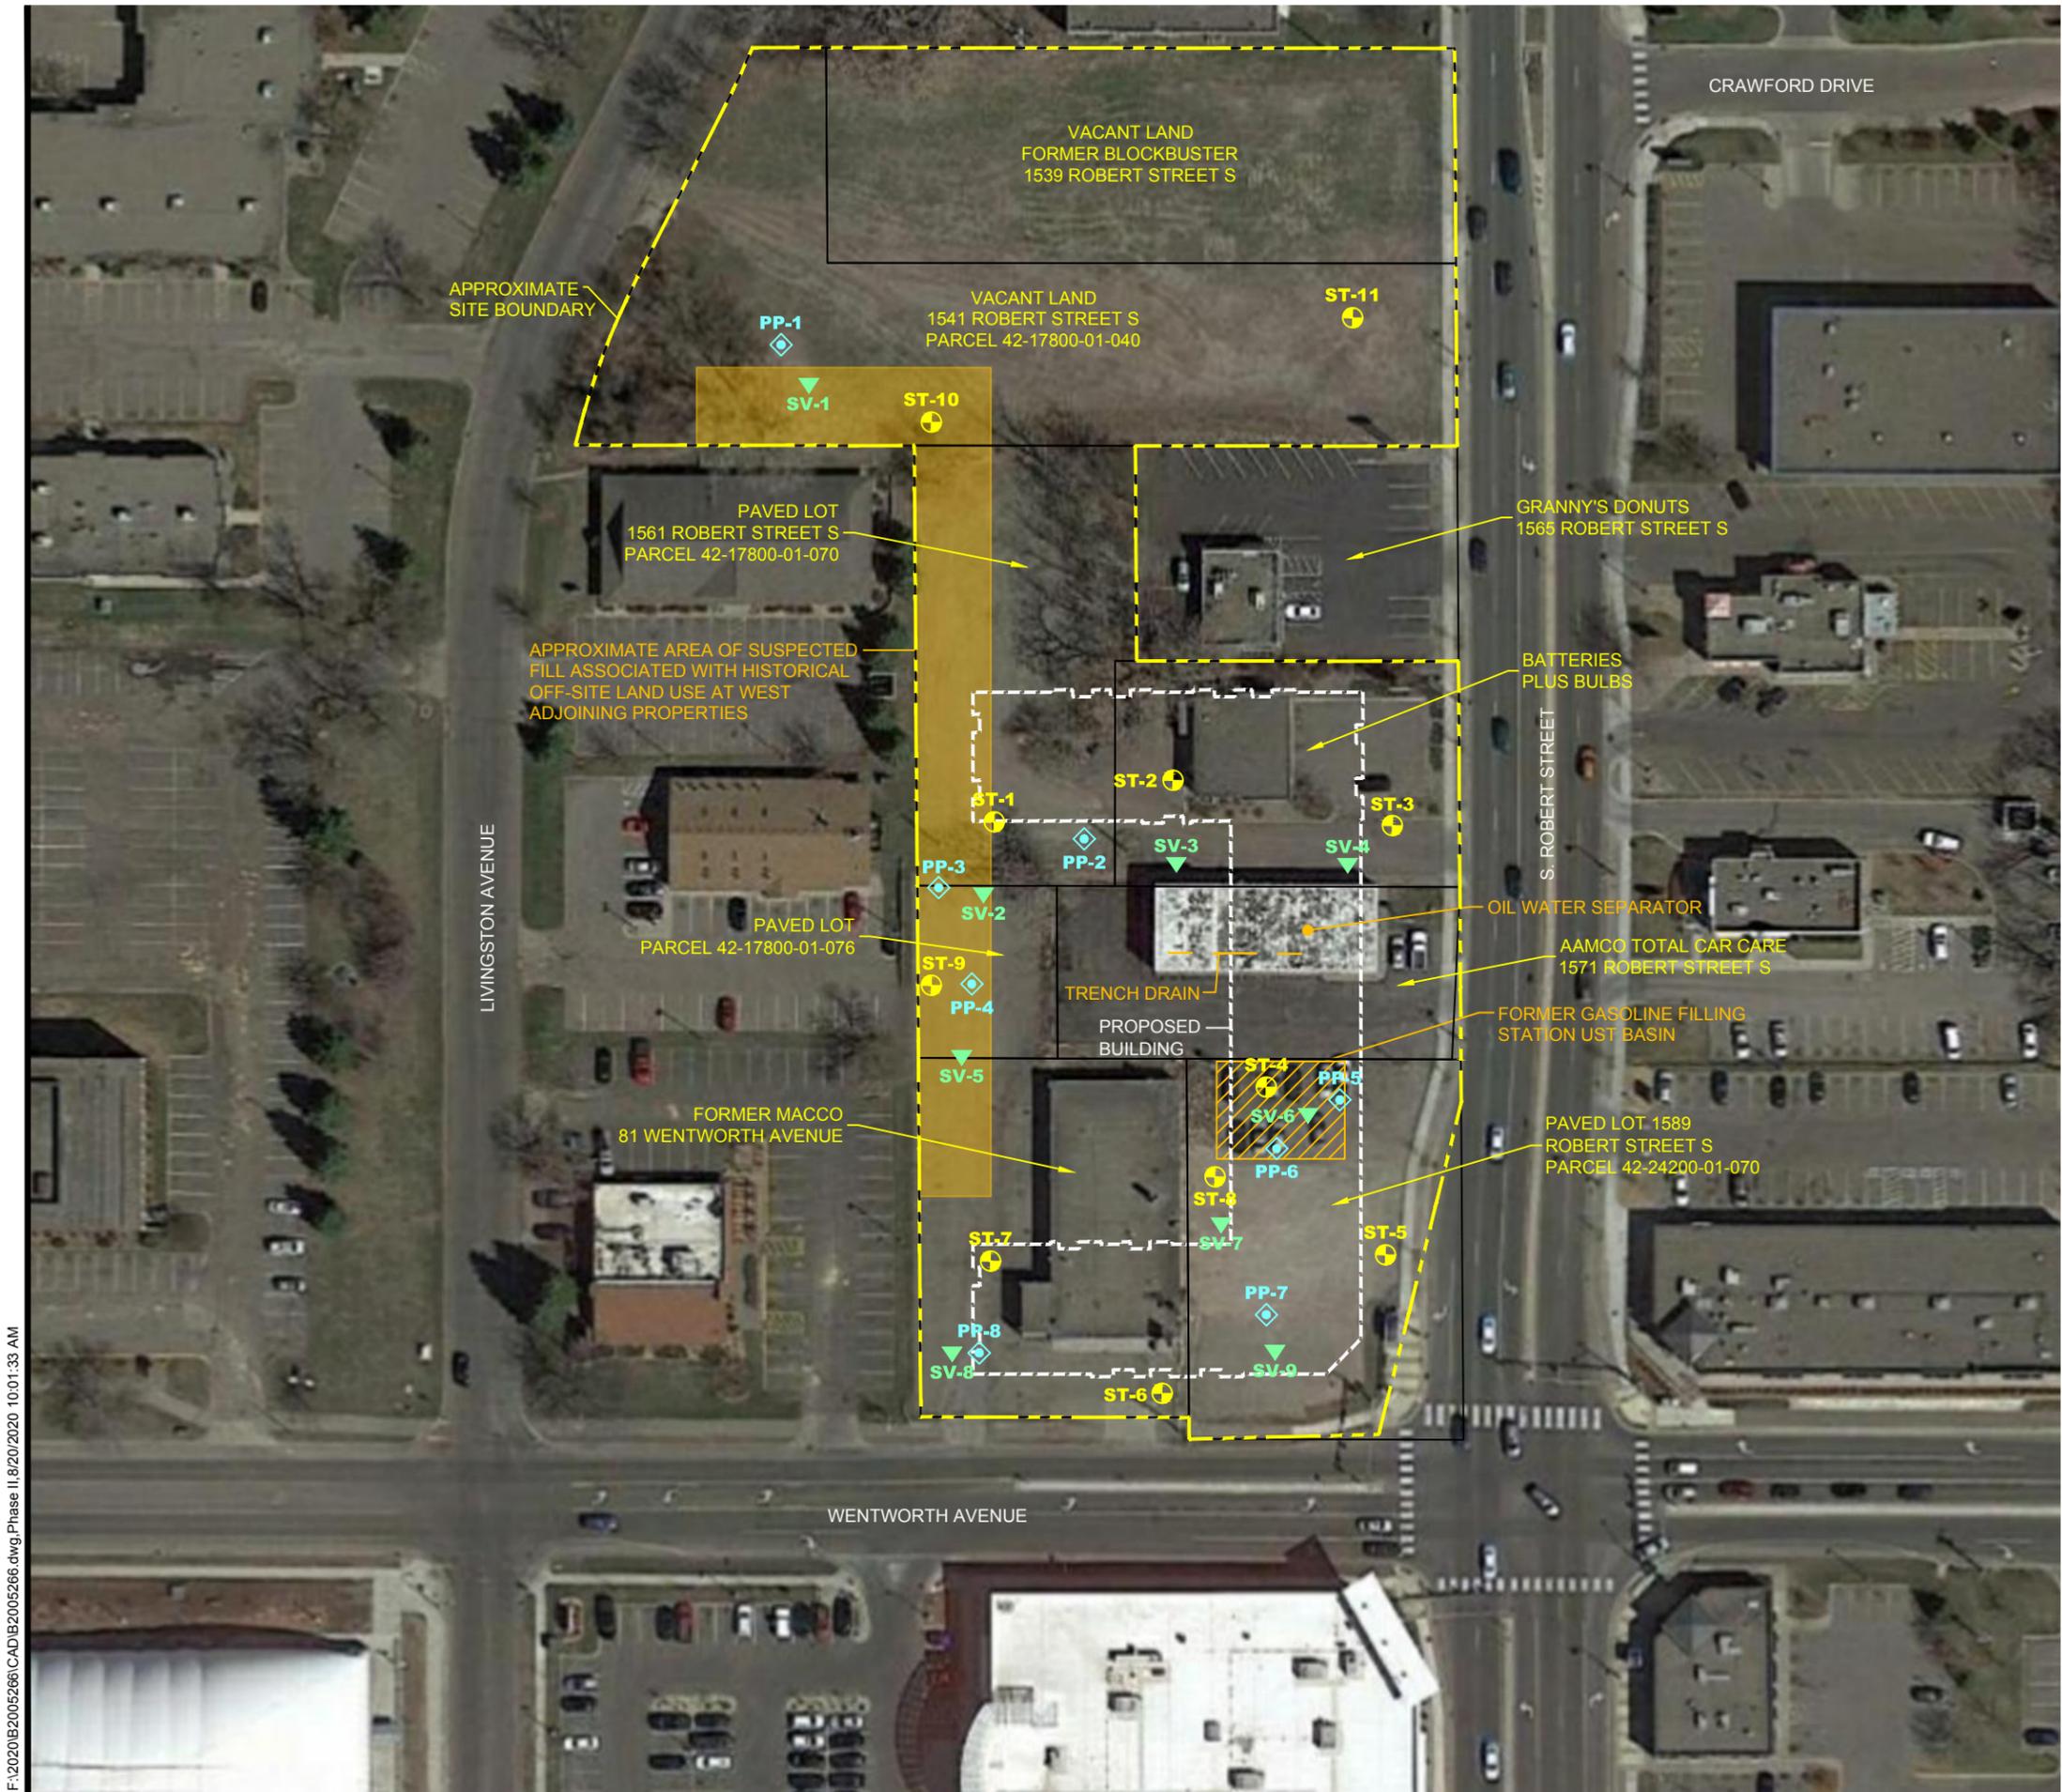
Debris Fragments: The Phase II ESA identified two areas with debris identified in the soil. Brick fragments were noted in boring PP-3 at 5 feet bgs and in boring PP-6 at 7.5 feet bgs. Soil boring PP-3 was located in the paved lot parcel 42-17800-01-076, and boring PP-6 was located in the 1589 Robert Street South parcel. In addition, the geotechnical evaluation noted brick fragments in boring ST-1 from 12 to 14 feet bgs.

- DENOTES APPROXIMATE LOCATION OF STANDARD PENETRATION TEST BORING**
- DENOTES APPROXIMATE LOCATION OF PUSH PROBE SOIL BORING**
- DENOTES APPROXIMATE LOCATION OF SOIL VAPOR PROBE**
